**VIDYA PRATISHTHAN'S  
KAMALNAYAN BAJAJ INSTITUTE OF  
ENGINEERING AND TECHNOLOGY, BARAMATI**

**DEPARTMENT OF CIVIL ENGINEERING**

**FIELD VISIT REPORT ON:**

**Study and understand Project Management Practices at  
Construction Site at Lonavala**

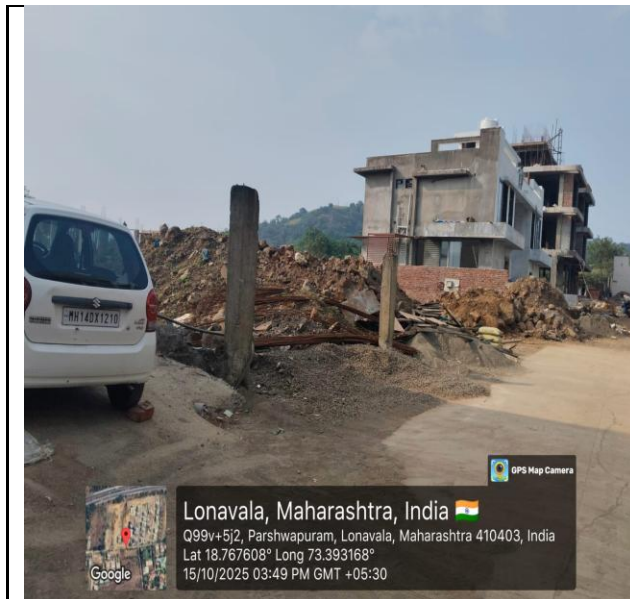
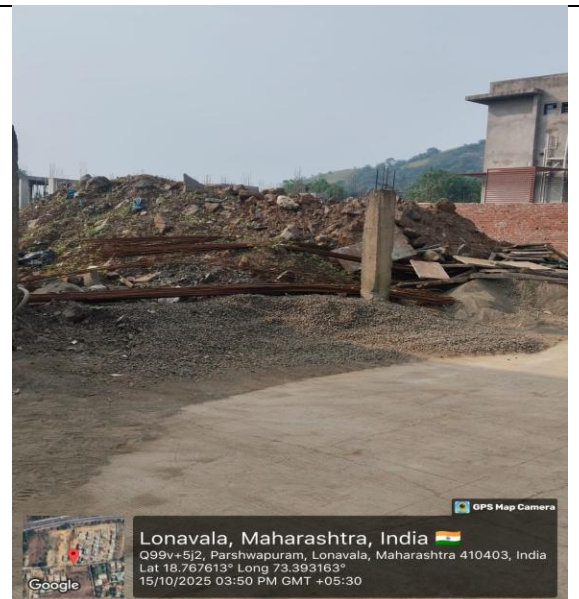
The site layout was found to be poorly organized. Boundaries were demarcated, but material storage facilities were inadequate. Labour huts were located near each villa site. Basic facilities such as drinking water and electricity were available. However, materials were not properly stacked -steel and aggregates were placed close to the construction area. A site office was available, and site access roads were maintained to ensure smooth movement of vehicles and materials.

- Materials such as cement, steel, and aggregates were not stored under covered sheds.
- Figure No. 3 shows that steel and shuttering materials were not properly stacked.
- Equipment such as JCBs, transit mixers, and drum mixers were being used efficiently.
- Concrete material testing was carried out at regular intervals.

**Fig. 3 Improper storage of Debris and steel**

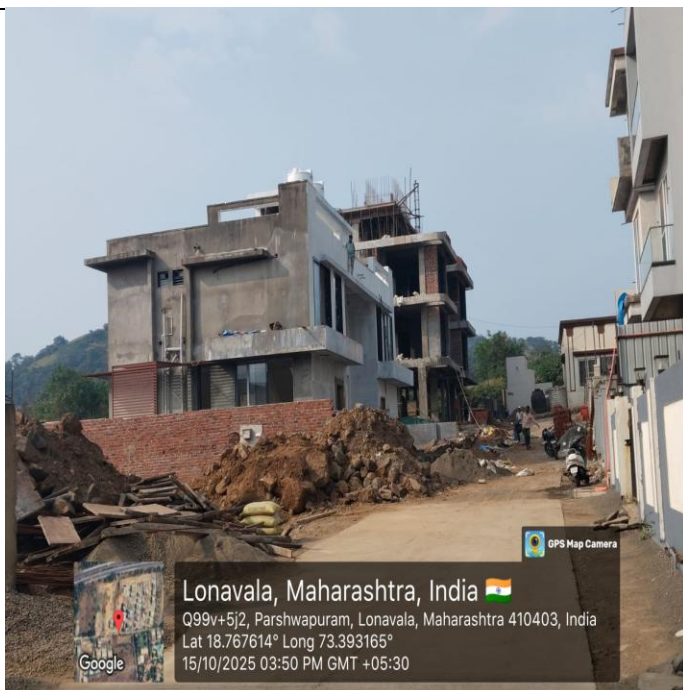
A lack of safety practices was observed at the site. Workers were found working at heights without proper safety measures. Personal protective equipment (PPE) such as gumboots, safety belts, and helmets were not being used. Additionally, safety signage's were not displayed at the site.

- Workers were not provided with adequate PPE kits such as helmets, gloves, and safety shoes.
- Safety signboards and barricades were not installed at the site.
- First-aid facilities and fire extinguishers were available in the site office.
- Figure No. 4 shows that workers did not follow any safety measures or precautions while working at elevated levels.

**a. Person working without safety**

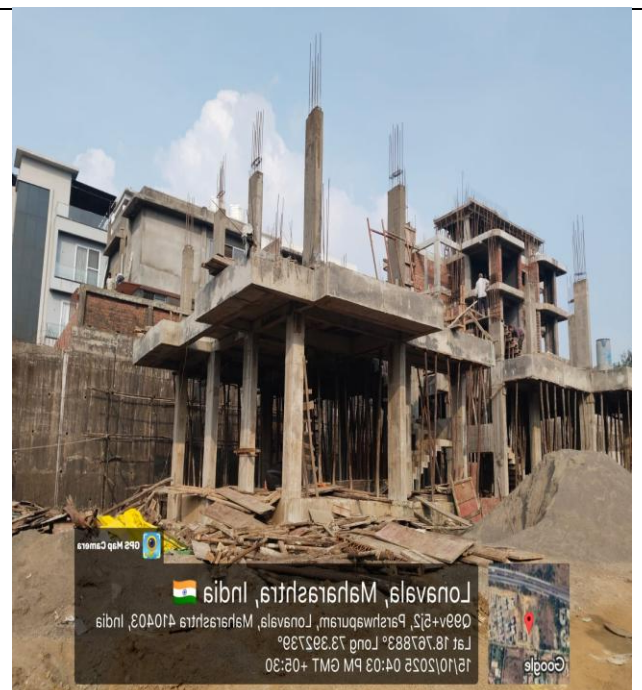
**b. Material stacked closed to site**

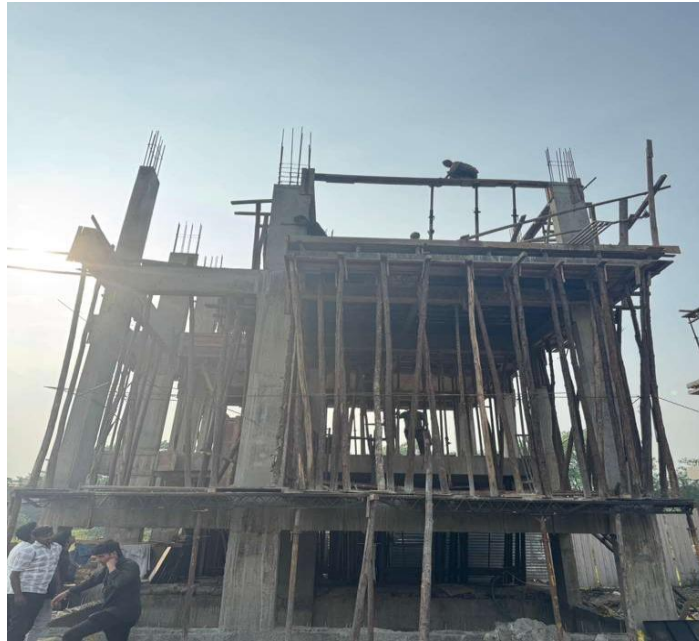
**c. Person working at higher level without safety**  
**Fig. 4 (a, b, c ) Lack of safety practices**
